Manhole Inspection Summary

Manhole # S33CC1014MH

Insp Date: **3/6/07 11:02 AM**

Location Address: **2 UNIVERSITY PKWY**

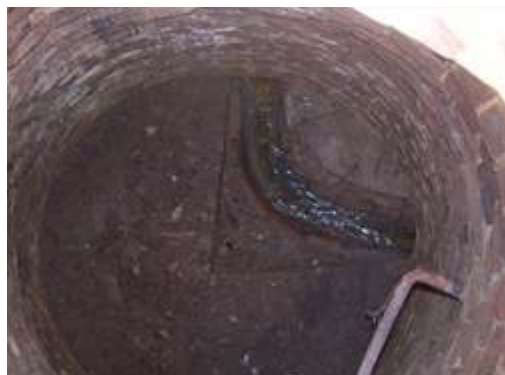
Top View

Adjustment, Corbel, and Barrel infiltration.
Evidence of surcharge - Bench debris.

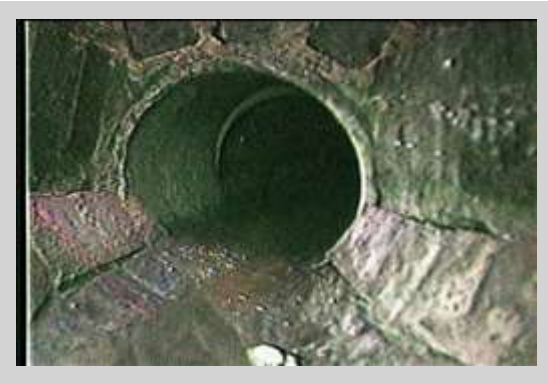
8 in. Circular Gravity Sewer Pipe Out @ 12 O'Clock

Channel deterioration.
